TECHNICAL INSPECTION REPORT

⑥ OPERATION CROSSROADS.
U.S.S. SKIPJACK (SS 184).

TEST BAKER.

VOLUME 1

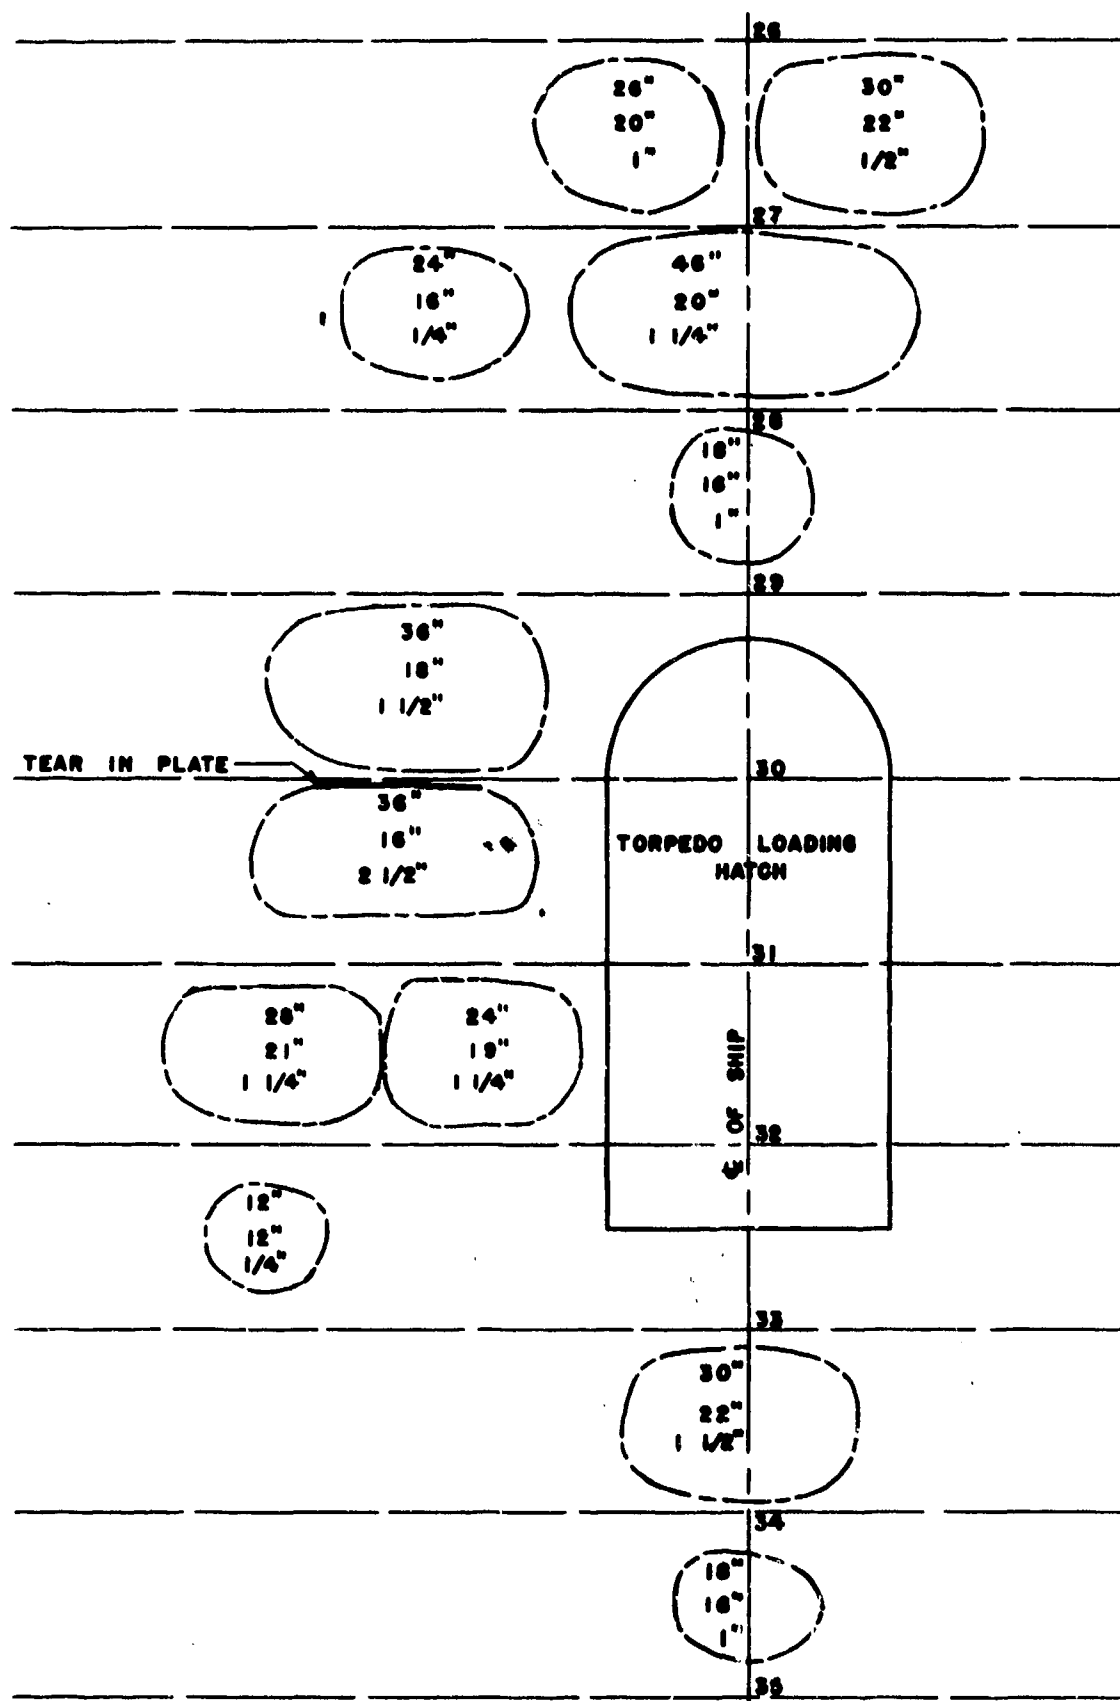
DIMPLES IN NON-CIRCULAR HULL IN WAY
OF FORWARD TORPEDO LOADING HATCH

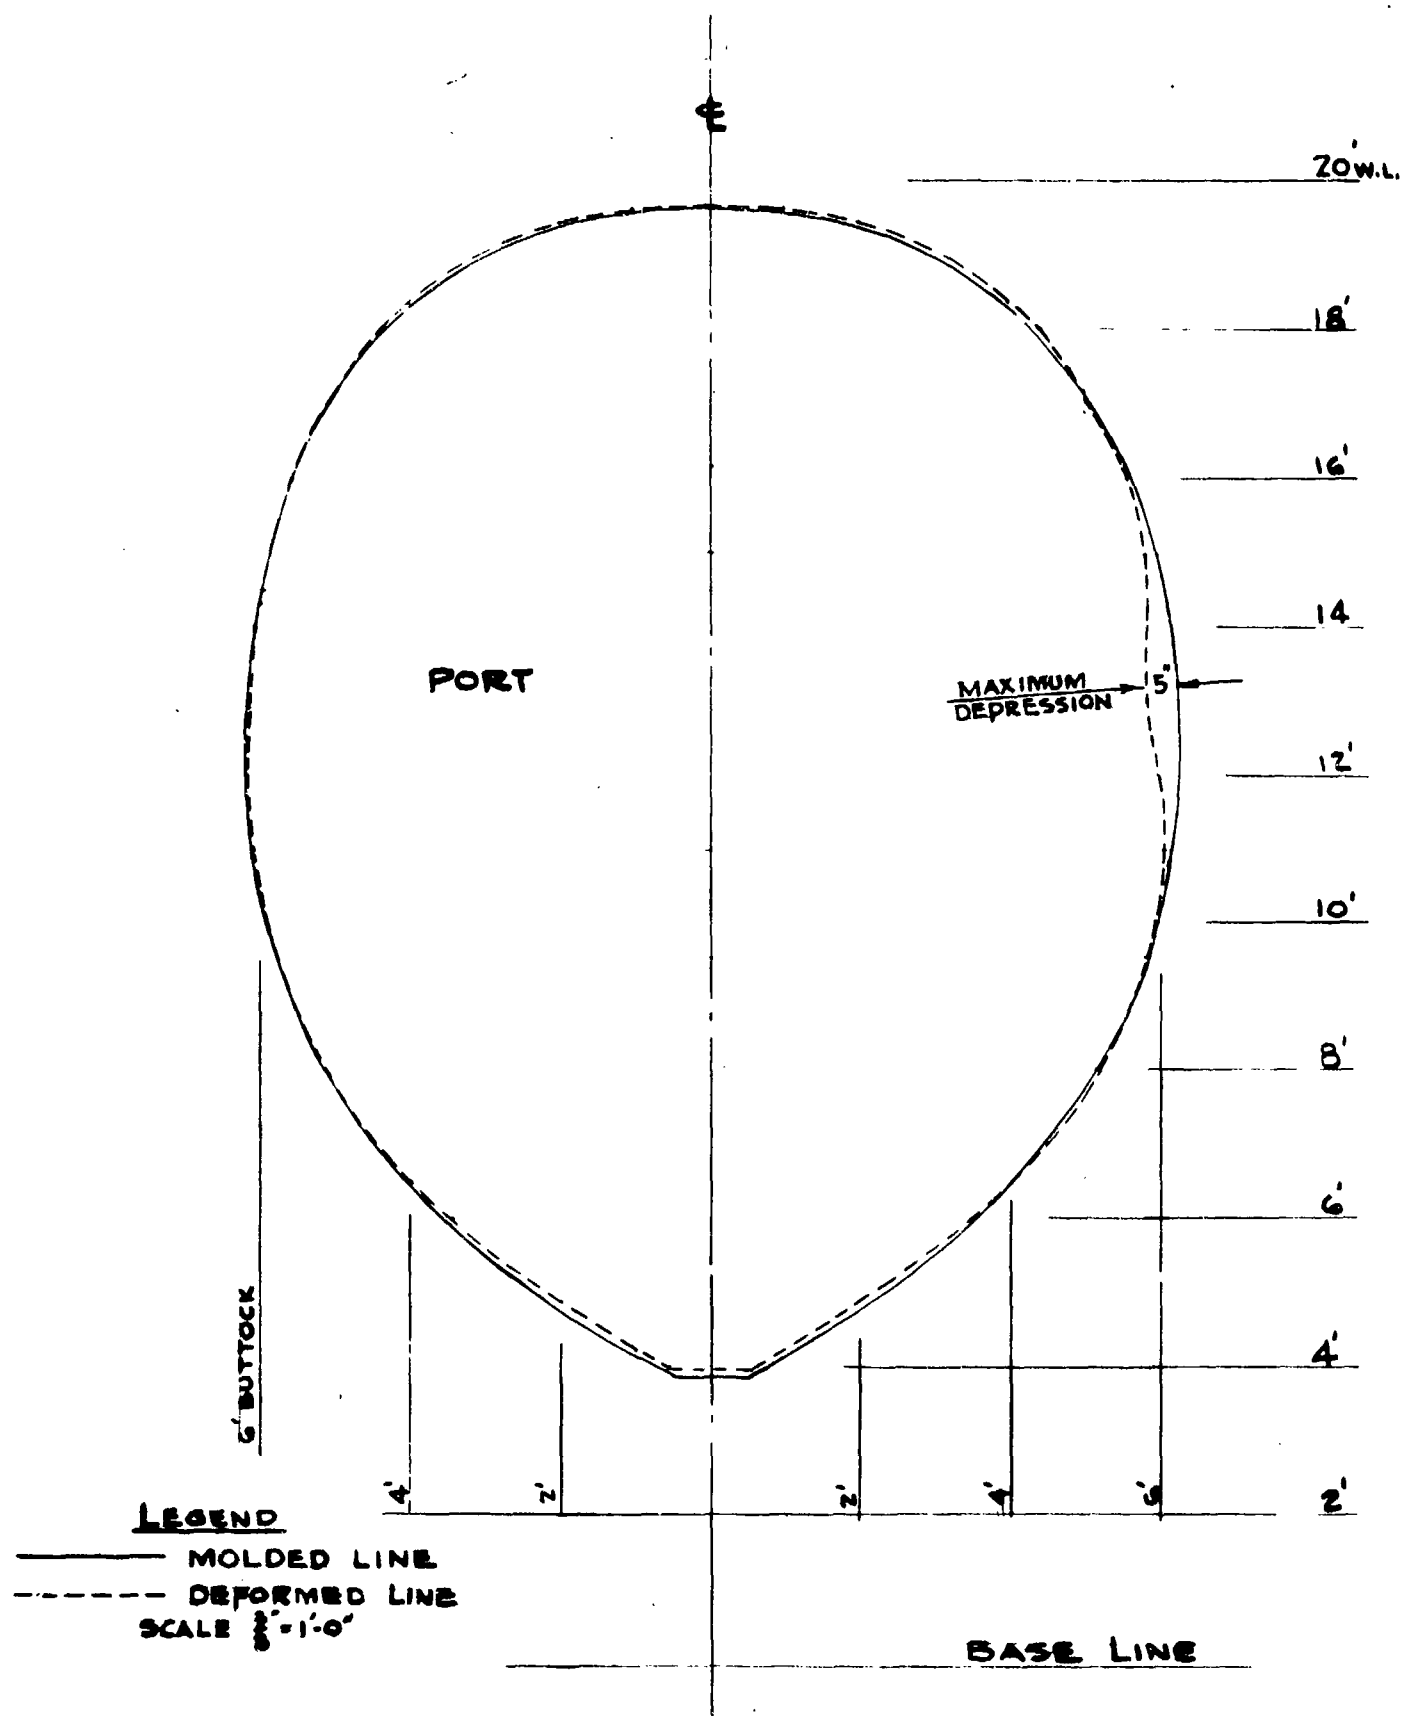
FRAME #21

Frame damage to the non-circular pressure hull was general but especially severe around frames 20 - 22 starboard.

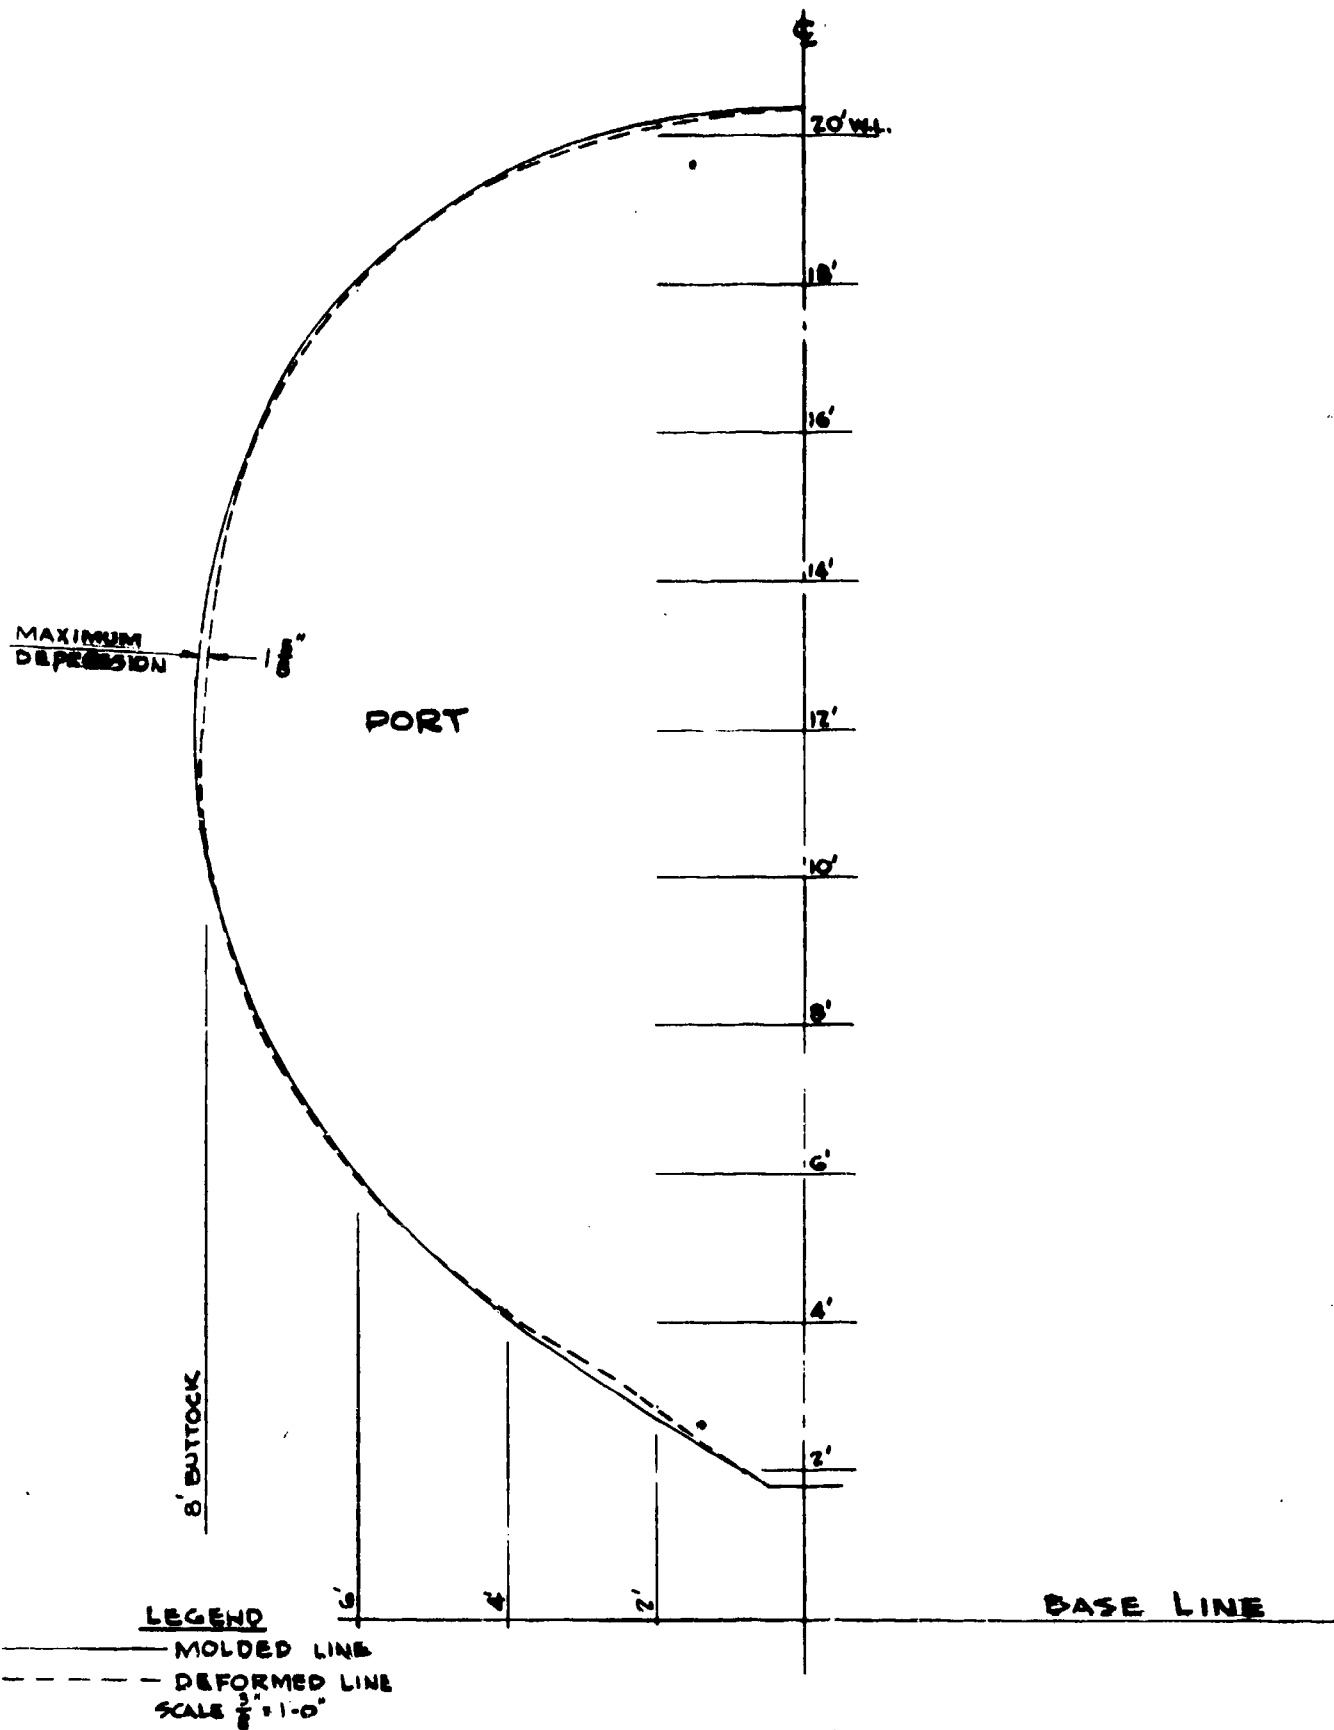
FRAME #30
PAGE 37 OF 141 U.S.S. SKIPJACK (S.S. 1847)

There was one break in the pressure hull plating. This occurred on the top of the forward torpedo room at frame 30, about 4 feet to port of the centerline. The fracture, which is 20 inches long, was in the immediate vicinity of the frame weld at the after edge of frame 30. It was repaired by a divers weld while the ship was on the bottom. The photographs on pages 66 and 67 of Volume II show the fracture, after the repair welding was done, from the exterior and interior, respectively. In the photograph on page 66 the extent of the fracture is marked roughly by the two white marks. A section of the hull containing the fracture was cut out and sand blasted and sent to the Bureau of Standards for metallurgical tests. In order to reduce the radioactivity, it was necessary to blast intensively with steel grit in the region of the fracture. This removed the divers repair weld almost completely. The photographs on pages 68 and 69 of Volume II show the fracture from above and below after blasting. There is very little if any, of the parent metal missing. In part the break appears to have been facilitated by insufficient penetration of the weld metal,

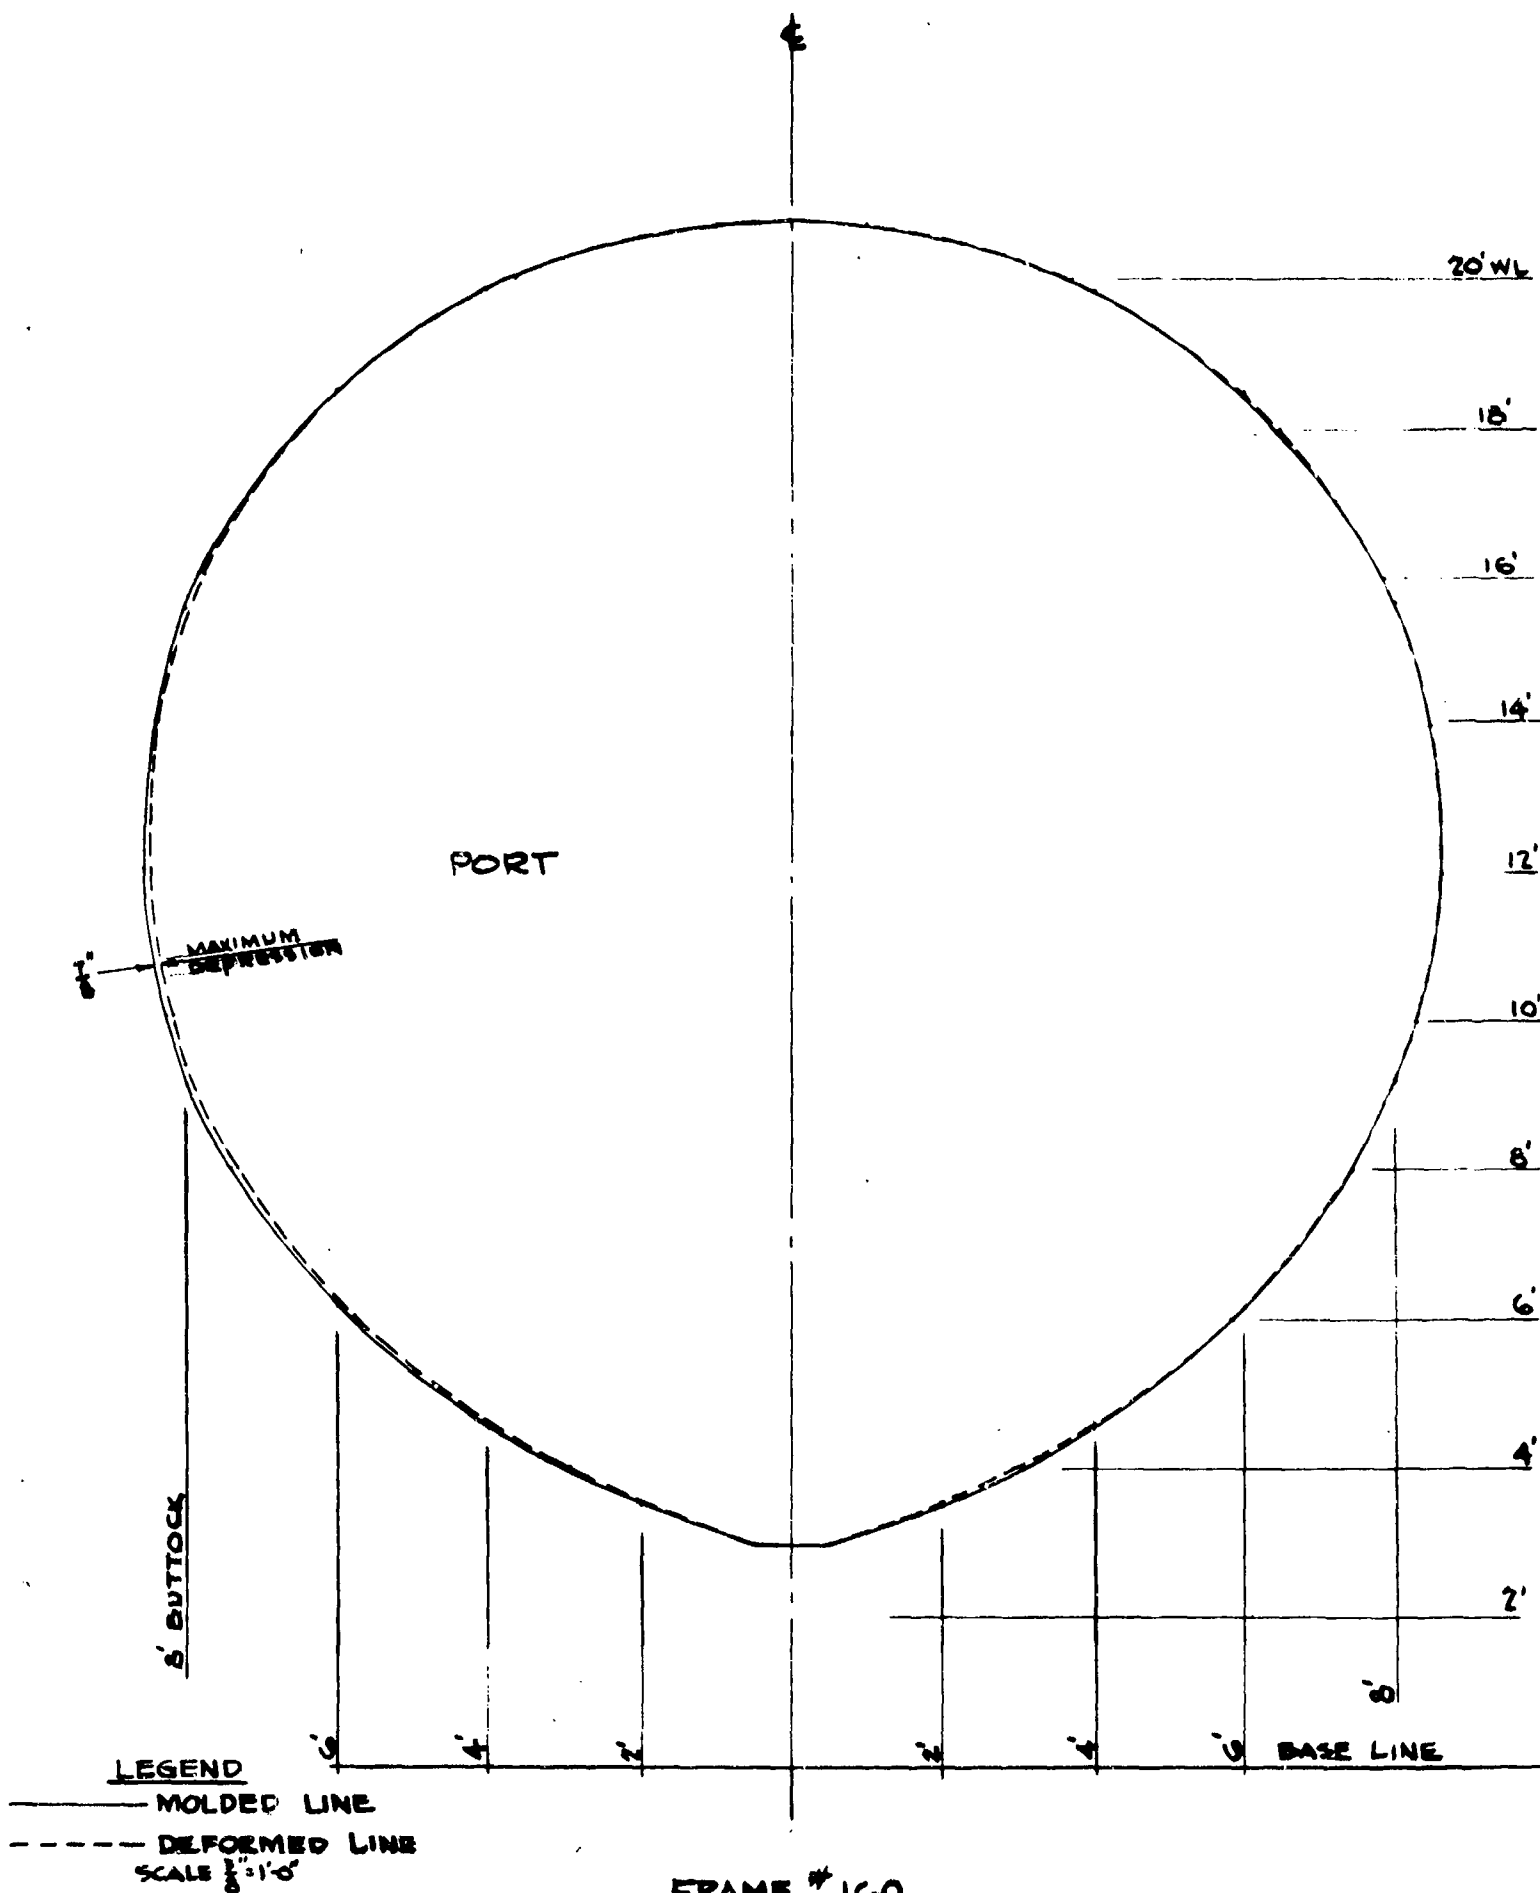
FRAME #160
 PAGE 48 OF 141 U.S.S. SKIPJACK (SS 184)
 7123

The entire area between frames 155 and 162 on the port side is severely damaged, the maximum depth of dimples being 3 inches. In Volume II, pages 22 and 23 show overall views of this area and pages 37, 38 and 39 show the close-up views. Between the same frames on the starboard side the distortion was much less severe, and occurred principally near the keel. Pages 28, 58 and 59 of Volume II show the starboard side.

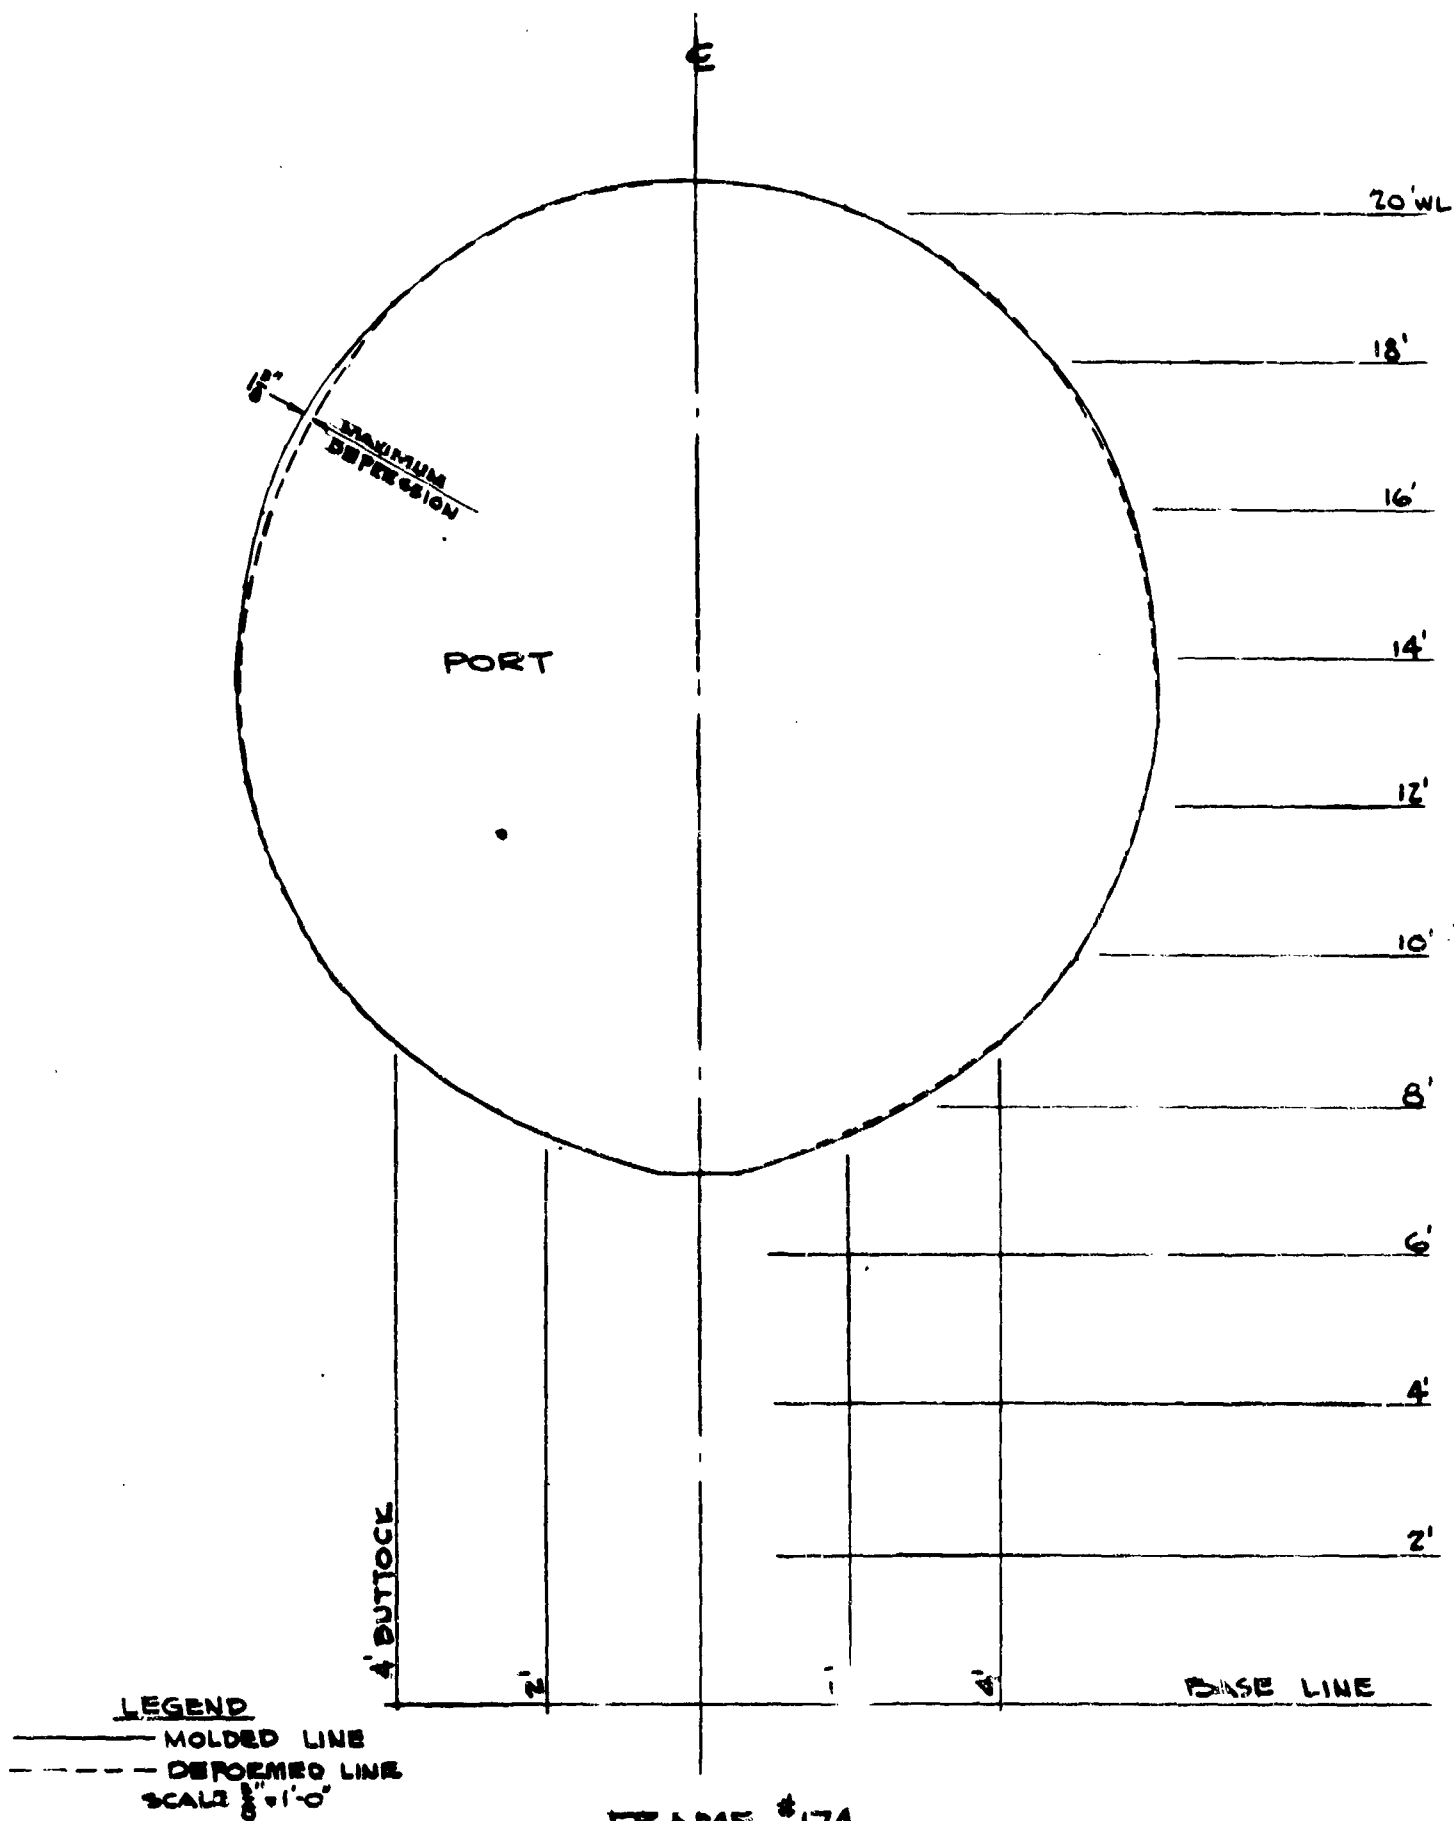
FRAME #174
 PAGE 50 OF 141 U.S.S. SKIPJACK (S.S. 184)
 7123

3. In the superstructure aft of the conning tower fairwater the only area of severe damage is between frame 173 and 179. Photograph on page 6 of Volume II shows the collapsed deck. Although there is no evidence to support such a theory, a heavy piece of structure blown through the air from another ship, or perhaps a large piece of coral, could have caused the damage. However, it appears more likely that sudden water pressure caused the collapse of the deck which in this area was somewhat weak due to the presence of an access hatch.
